BEECHWOOD DAM #2 TURBINE REFURBISHMENT

LOCATION: BEECHWOOD, NB

JOB REFERENCE: I-1-14

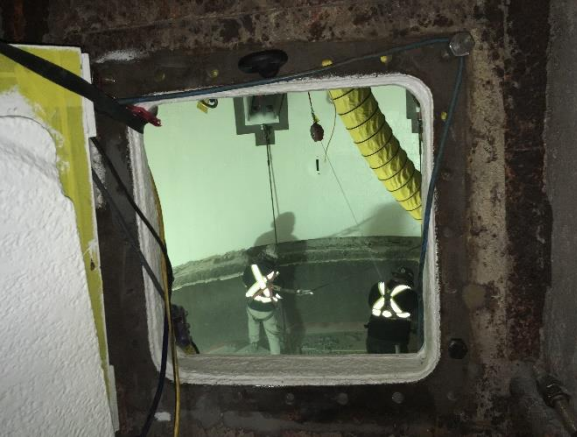
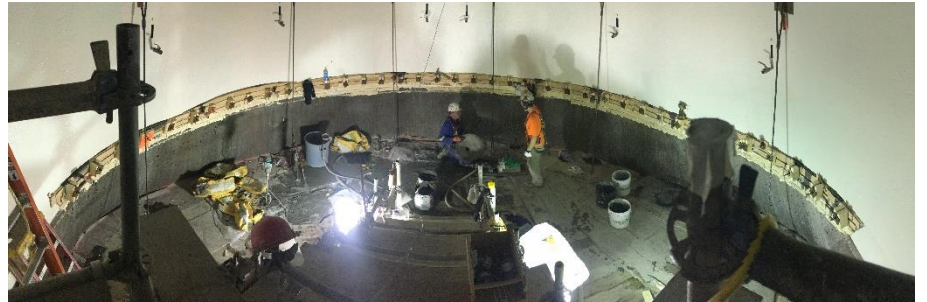
CONSTRUCTION: AUS WAS CONTRACTED TO REPAIR THE CONCRETE WALL SURFACE IN THE DRAFT TUBE JUST BELOW THE TURBINE ELEVATION. ONCE INSIDE WE OBSERVED THAT THE EXISTING COLD JOINT IN THE ORIGINAL

CONCRETE WAS ERRODING DUE TO THE VOLUME OF WATER FORCED THROUGH THE DRAFT TUBE. THE COLD JOINT WAS OPENED UP, STEEL REINFORCING WAS ADDED, FORMWORK WAS BENT TO THE CURVE AND TAPER OF THE TUBE AND THEN FLOWABLE GROUT WAS PUMPED INTO THE VOID.
