POOL COATING AT MONCTON CITY HALL

LOCATION: MONCTON, NB

CONSTRUCTION: AUS WAS TASKED WITH REMOVING AND REPLACING THE DETERIORATING COATING IN THE WATER FOUNTAIN

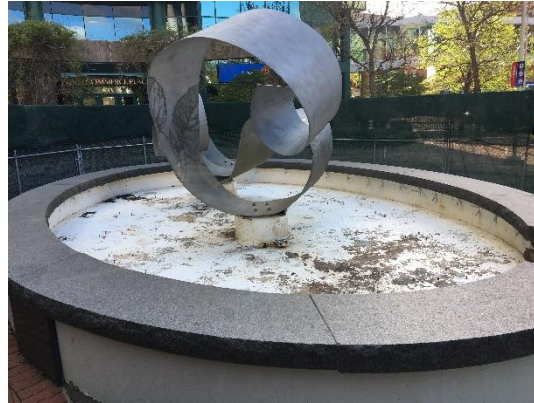
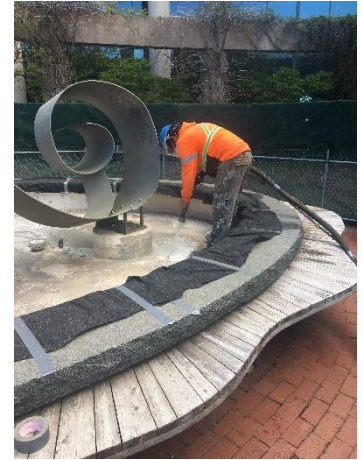
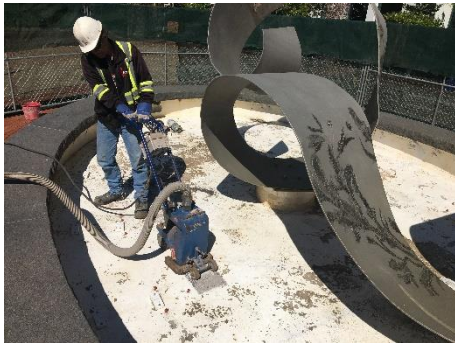
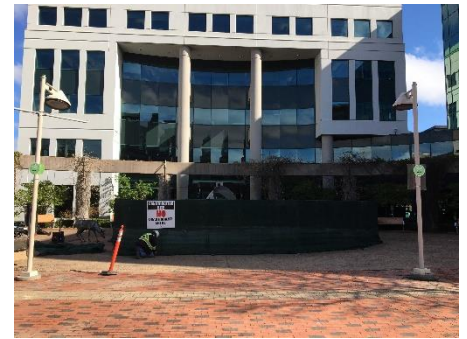
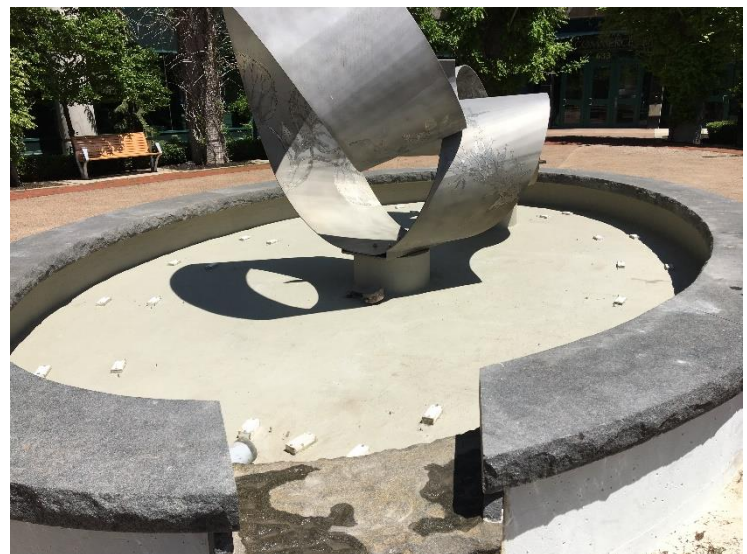
LOCATED INFRONT OF THE MONCTON CITY HALL. THE REMOVAL OF THE COATING WAS DONE WITH A COMBINATION OF SHOT BLASTING AND WET SANDBLASTING. AN ECTOFLEX COATING WAS THEN BRUSH APPLIED. THE RESULT WAS A WATERTIGHT SOLUTION THAT VISIBLY APPEALING.

UNIQUENESS: THE LOCATION OF THE WATER FOUNTAIN WAS A HIGH FOOT TRAFFIC AREA THAT REQUIRED EXTRA PROTECTION TO ENSURE PUBLIC SAFETY. FENCING AND MESH WERE INSTALLED TO CONTAIN ANY FLYING DEBRIS AND WET SANDBLASTING WAS CONDUCTED TO ENSURE NO DUST WAS MADE.
