MAGNETIC HILL ZOO OTTER POOL COATING

LOCATION: MONCTON NB

OWNER: CITY OF MONCTON
JOB REFERENCE: AUS #J-1-27
DATE: AUGUST 2020

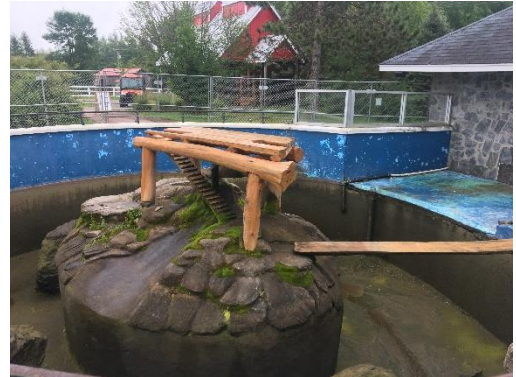
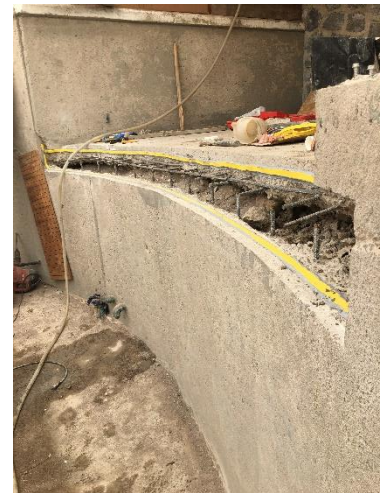
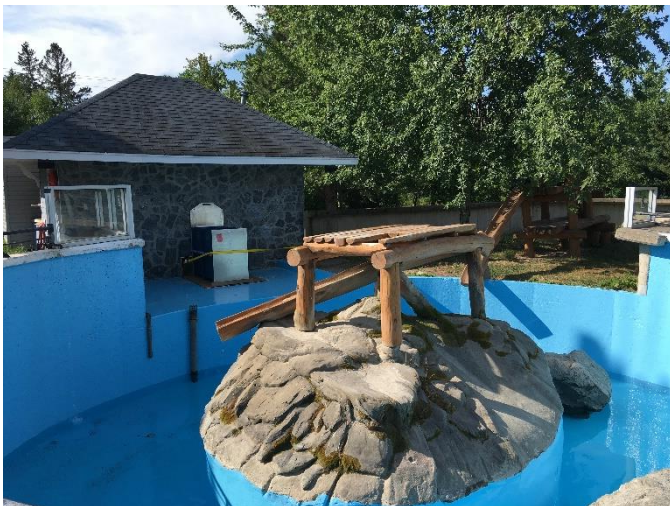
CONSTRUCTION: AUS WAS TASKED APPLYING A NEW COATING TO THE OTTER POOL AND STOPPING THE POOL FROM CONTINUING TO LEAK WATER. WITH THE POOL DRAINED A CONCRETE REPAIR WAS PERFORM AT THE AREA OF THE LEAK. THE WALLS AND FLOOR WERE SANDBLASTED TO BARE CONCRETE AND AN EPOXY COATING WAS APPLIED.
