## TOWER ROAD DAM AND RESERVOIR

**LOCATION:** RIVERVIEW, NB

**CONSTRUCTION:** AUS WAS CONTRACTED TO INSTALL ROCK ANCHORS AND PRESSURE GROUT A CURTAIN WALL ACROSS THE TOE OF THE NEW TOWER ROAD DAM. THE PRESSURE GROUTING OF 610 PRIMARY HOLES AND THE RESULTING ADDITIONAL 350 SECONDARY HOLES TOOK OVER 6 MONTHS.

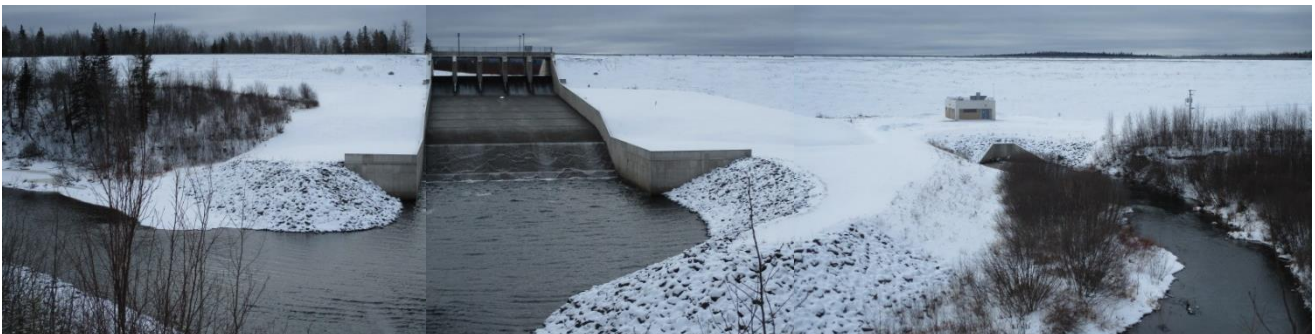
**UNIQUENESS:** IN ORDER TO ALLEVIATE THE THREAT OF MIGRATING WATER BENEATH THE EARTHEN DAM AND CONTROL STRUCTURE, A GROUT CURTAIN WALL WAS INSTALLED TO SEAL VOIDS IN BEDROCK. GROUT WAS PUMPED INTO HOLES DRILLED IN BEDROCK AT PRESSURES CALCULATED TO OVERCOME THE NATURAL HYDROSTATIC PRESSURES FOUND BENEATH THE EXISTING GRADE.

AUS ALSO INSTALLED 1-3/8" GALVANIZED ROCK ANCHORS TO SECURE THE SPILLWAY TO THE NATURAL BEDROCK.
